BIENNIAL TREE SURVEY REPORT

Report No. S/25/17

**Services Committee
23rd July 2025**

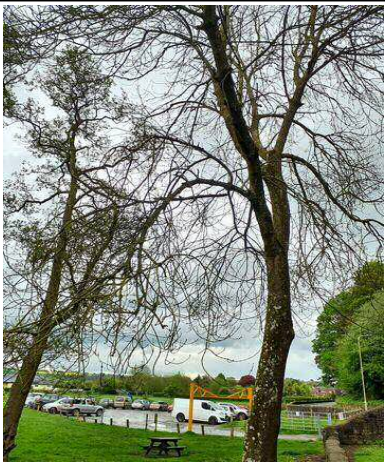
Ref.	Species	Location	Measurements	Task	Priority	Photo	
2025/0104	Common ash (<i>Fraxinus excelsior</i>)	Grassed area by retaining wall and toilet block Formal Park	Height (m): 25 Crown Spread (m): 15 DBH (cm): 75 Maturity: Mature Life Exp.: M (10-20 Years)	Remove dead branch at 9m facing the river	6 Months

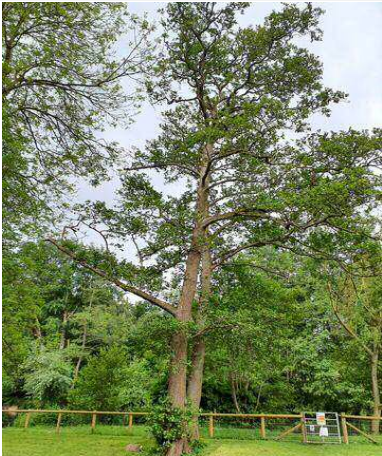
2025/0105	Common alder (<i>Alnus glutinosa</i>)	1 of 2 close growing trees toward toilet block	Height (m): 20 Crown Spread (m): 15 DBH (cm): 75 Maturity: Mature Life Exp.: M (10-20 Years)	Remove all major deadwood (>80mm dia) & stubs from throughout crown. Shorten branches back to live growth where branch ends are dead	6 Months

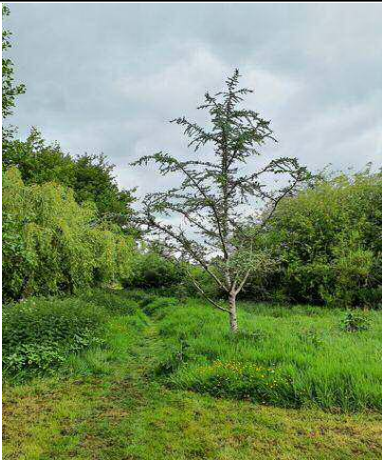
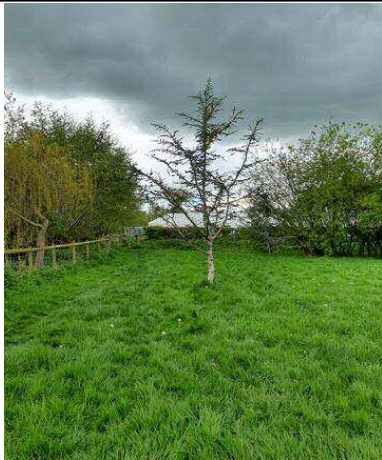
2025/0131	Blue cedar (<i>Cedrus atlantica glauca</i>)	Grassed area near willow sculpture Formal Park	Height (m): 5 Crown Spread (m): 5 DBH (cm): 10 Maturity: Young Life Exp.: L (20-40 Years)	Application of mulch spread as evenly as practicable to a depth of 75 mm over an area of 1 metre diameter with the tree at the centre. The mulch shall comprise of wood chips & leaves which have been composted for at least 6 months and shall not be piled against the bark of the tree.	6 Months

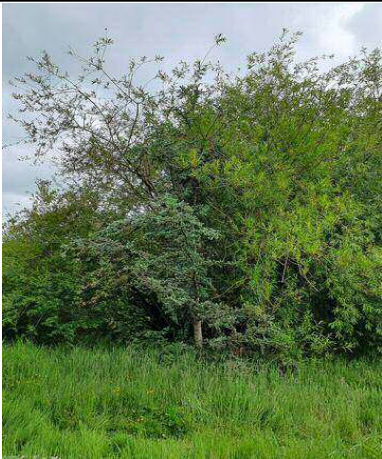
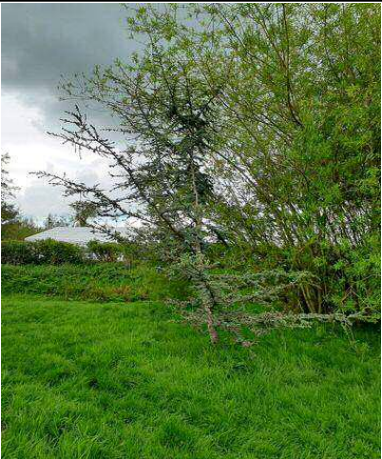
Ref.	Species	Location	Measurements	Task	Priority	Photo		Photo	
2025/0132	Blue cedar (<i>Cedrus atlantica glauca</i>)	Grassed area near outgrown willow sculpture Formal Park	Height (m): 5 Crown Spread (m): 5 DBH (cm): 10 Maturity: Young Life Exp.: L (20-40 Years)	Cut back willow to provide 3m clearance. Application of mulch spread as evenly as practicable to a depth of 75 mm over an area of 1 metre diameter with the tree at the centre. The mulch shall comprise of wood chips & leaves which have been composted for at least 6 months and shall not be piled against the bark of the tree.	6 Months

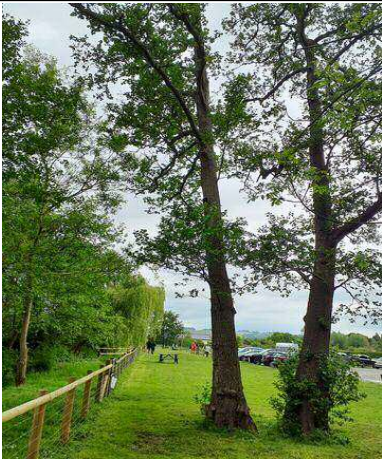
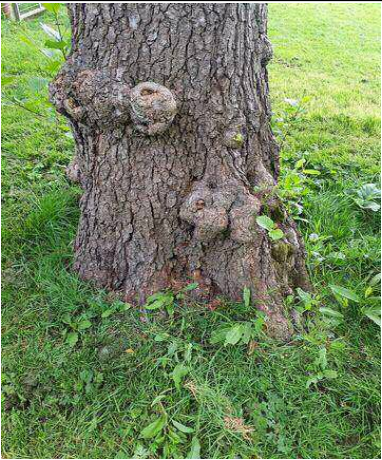
2025/0106	Common alder (<i>Alnus glutinosa</i>)	2 of 2 close growing trees close to picnic bench	Height (m): 20 Crown Spread (m): 15 DBH (cm): 75 Maturity: Mature Life Exp.: M (10-20 Years)	Fell to ground level	1 Year

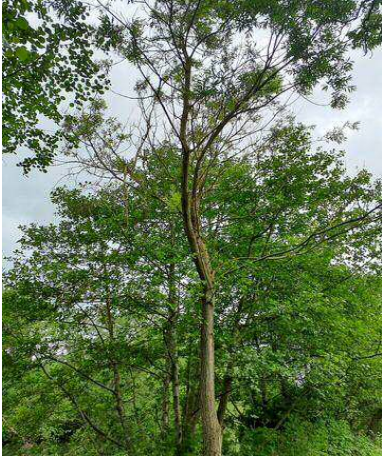
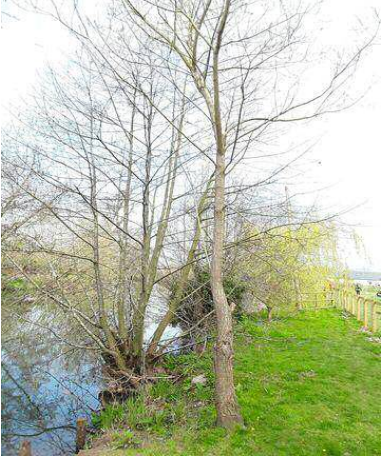
2025/0108	White willow (<i>Salix alba</i>)	In area between fence & river Formal Park	Height (m): 15 Crown Spread (m): 5 DBH (cm): 30 Maturity: Young Life Exp.: L (20-40 Years)	Pollard tree at 3m to create new crown and force tree to react.	1 Year

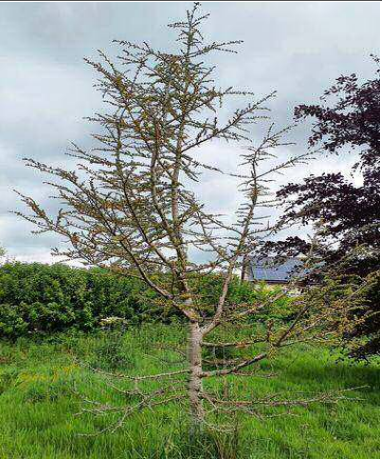
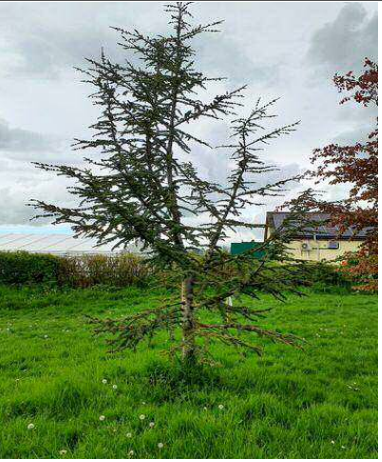
Ref.	Species	Location	Measurements	Task	Priority	Photo			Photo		
2025/ 0138	Blue cedar (<i>Cedrus atlantica glauca</i>)	Grassed area in northern end of park Formal Park	Height (m): 5 Crown Spread (m): 5 DBH (cm): 10 Maturity: Young Life Exp.: S <(10 years)	Fell to ground level Replace with Dawn Redwood	1 Year

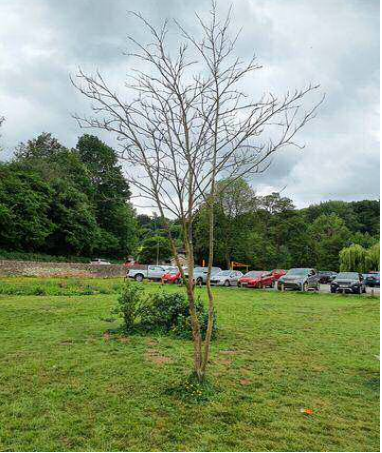
2025/ 0144	Sorbus 'commixta' (<i>Sorbus sp.</i>)	Grassed area near play area and benches Formal Park	Height (m): 5 Crown Spread (m): 5 DBH (cm): 10 Maturity: Young	Fell to ground level	1 Year

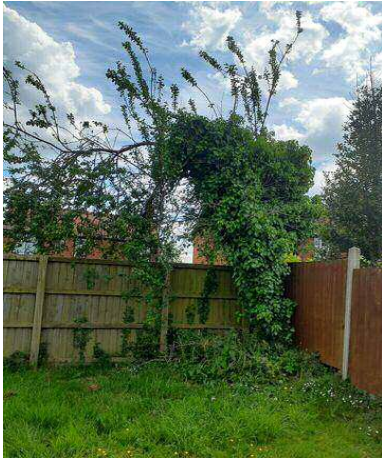
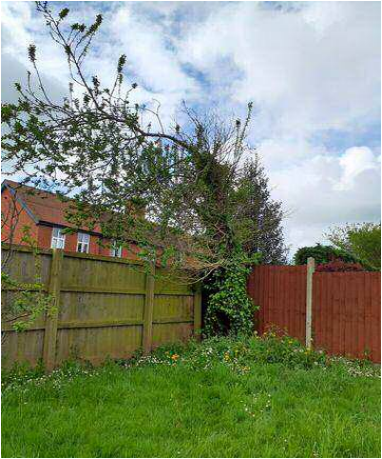
Ref.	Species	Location	Measurements	Task	Priority	Photo		Photo	
2025/ 0166	Plum (<i>Prunus domestica</i>)	In the corner of the open space by the fences	Height (m): 5 Crown Spread (m): 5 DBH (cm): 30 Stems: 2 Maturity: Semi Mature Life Exp.: M (10-20 Years)	Sever Ivy from ground level to 1.2m. To facilitate reinspection	1 Year

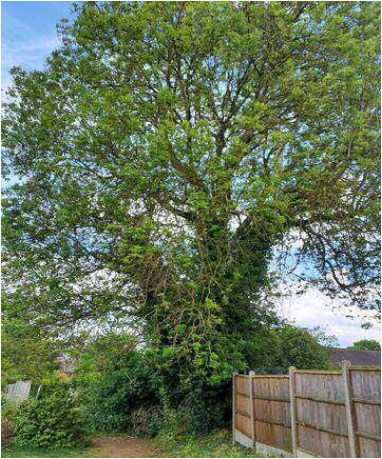
Ref.	Species	Location	Measurements	Task	Priority	Photo		Photo	
2025/0164	Common ash (<i>Fraxinus excelsior</i>)	In old hedge bordering the right of way. Next to garden fence.	Height (m): 25 Crown Spread (m): 15 DBH (cm): 55 Stems: 2 Maturity: Mature Life Exp.: L (20-40 Years)	Sever Ivy & any other climbers from ground level to 1.2m on two stems. To facilitate reinspection.	6 Months

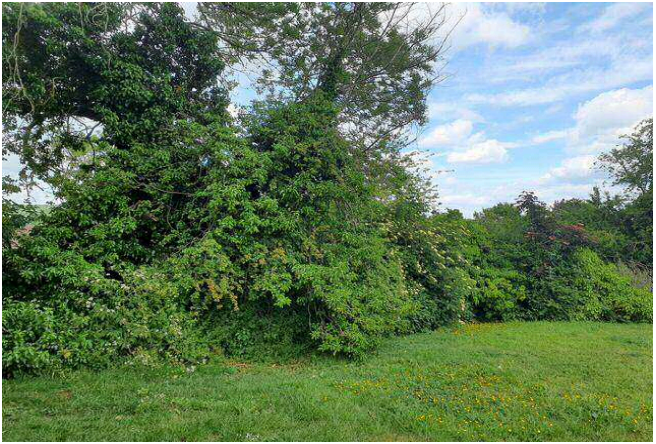
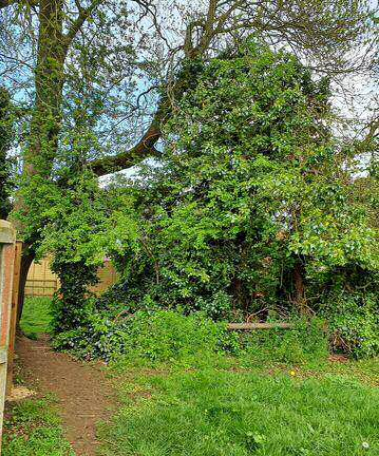
2025/0168	Common hawthorn x3 (<i>Crataegus monogyna</i>)		Remnant of old hedge between open space and right of way.	Over Mature	3	M (10-20 Years)	5	5	40	F	F	within hedge	Play Area, Footway	Minor	2 Years	All heavily smothered in ivy. One stem collapsed at 2.5m into open space. The remaining trees are becoming smothered by ivy and are increasingly likely to fail in strong winds. The hedge feature is being lost as a result. Still no safety issues, but good maintenance suggests ivy severance initially and reassess during next safety assessment. This was previously recommended and no severance has happened.	None	Not Assessed	Not Assessed

Stem cavity & torsional tibs	
2025/0168	Common hawthorn x3 (<i>Crataegus monogyna</i>)	Remnant of old hedge between open space and right of way.	Height (m): 5 Crown Spread (m): 5 DBH (cm): 40 Trees: 3 Maturity: Over Mature Life Exp.: M (10-20 Years)	Sever Ivy from ground level to 1.2m on the 3 Hawthorn stems	6 Months

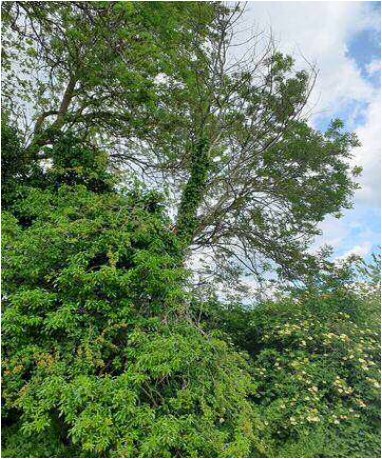
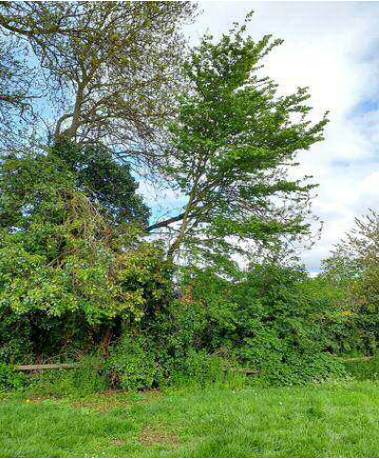
2025/0169	English elm x2 (<i>Ulmus procera</i>)	Two close growing trees next to rail fence	Height (m): 10 Crown Spread (m): 5 DBH (cm): 10 Trees: 2 Life Exp.: M (10-20 Years)	Fell dead Elm to ground level	1 Year

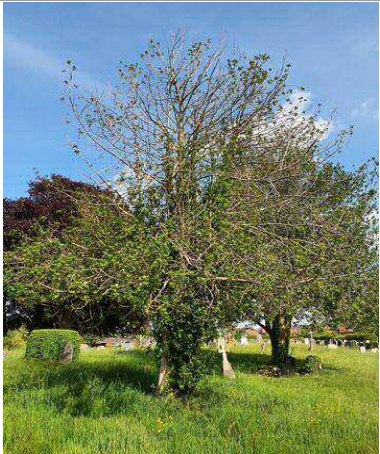
Ref.	Species	Location	Measurements	Task	Priority	Photo		Photo
2025/0011	Common holly (<i>Ilex aquifolium</i>)	In centre of old cemetery area Cemetery	Height (m): 10 Crown Spread (m): 10 DBH (cm): 70 Maturity: Mature Life Exp.: M (10-20 Years)	Advisory - Fell to ground level	1 Year

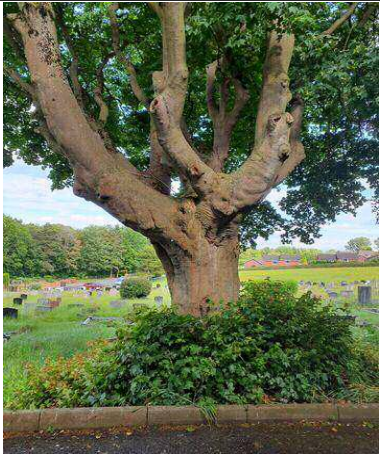
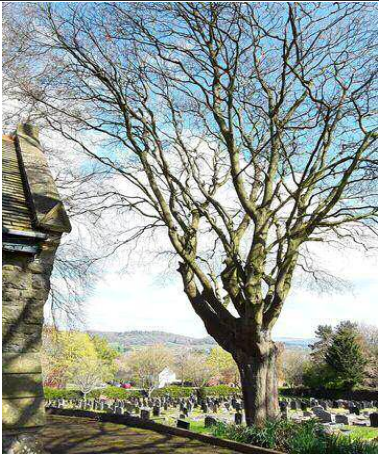
2025/0015	Cappadocian maple (<i>Acer cappadocicum</i>)		edge of grassed area opposite the end of the chapel building	Mature	1	L (20-40 Years)	20	15	90	G	G	Grassed area	Chapel	6Major	2 Years	Crown Lifted in past with some evidence of the wounds decaying back. Basal epicormic growth developing	None	Not Assessed	Not Assessed	Not Assessed

May 2023 test result
2025/0015	Cappadocian maple (<i>Acer cappadocicum</i>)	edge of grassed area opposite the end of the chapel building	Height (m): 20 Crown Spread (m): 15 DBH (cm): 90 Maturity: Mature Life Exp.: L (20-40 Years)	Advisory - Remove Basal Epicormic and adventitious growth from buttresses and trunks of trees, from ground level to no higher than 2.5m.	1 Year

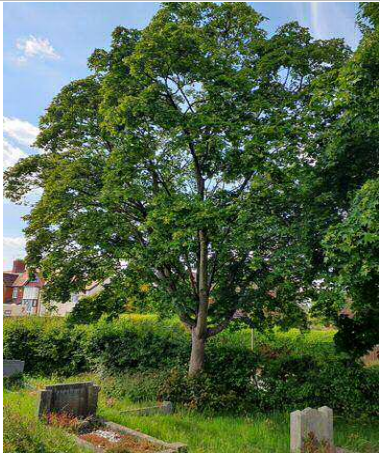
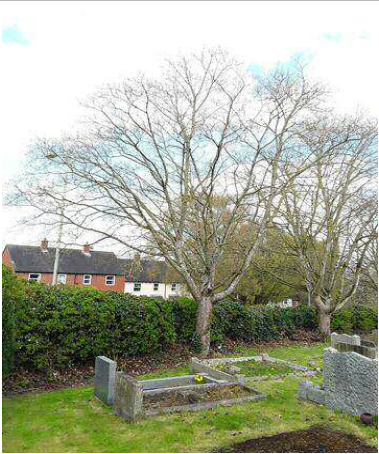
2025/0028	Cappadocian maple (<i>Acer cappadocicum</i>)	1st in line of trees next to roadside hedge	Height (m): 10 Crown Spread (m): 10 DBH (cm): 40 Maturity: Mature Life Exp.: L (20-40 Years)	Advisory- Remove Basal Epicormic and adventitious growth from buttresses and trunks of trees, from ground level to no higher than 2.5m.	1 Year

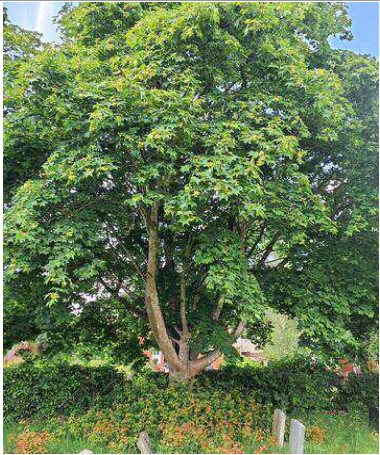
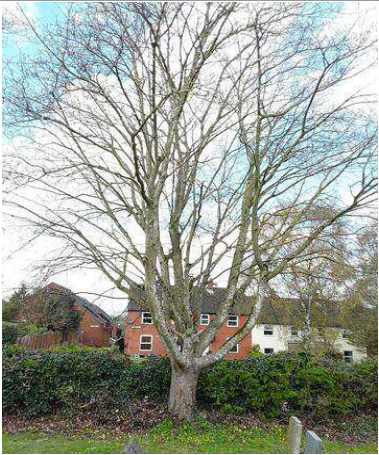
Ref.	Species	Location	Measurements	Task	Priority	Photo		Photo
2025/0029	Cappadocian maple (<i>Acer cappadocicum</i>)	2nd in line by roadside hedge	Height (m): 10 Crown Spread (m): 10 DBH (cm): 60 Maturity: Semi Mature Life Exp.: EL (40+ Years)	Advisory - Remove Basal Epicormic and adventitious growth from buttresses and trunks of trees, from ground level to no higher than 2.5m.	1 Year

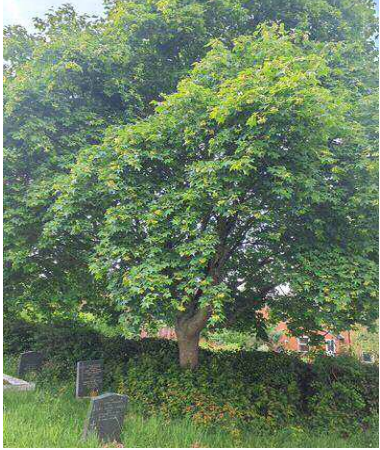
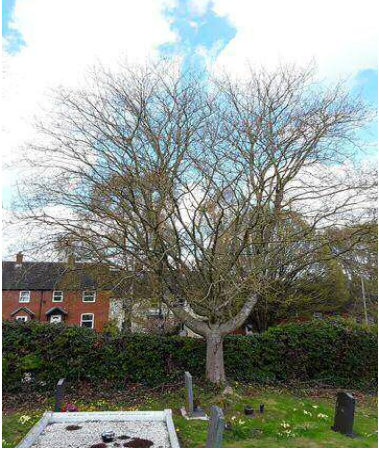
2025/0030	Cappadocian maple (<i>Acer cappadocicum</i>)	3rd in line by roadside hedge	Height (m): 10 Crown Spread (m): 10 DBH (cm): 50 Maturity: Semi Mature Life Exp.: EL (40+ Years)	Advisory - Remove Basal Epicormic and adventitious growth from buttresses and trunks of trees, from ground level to no higher than 2.5m.	1 Year

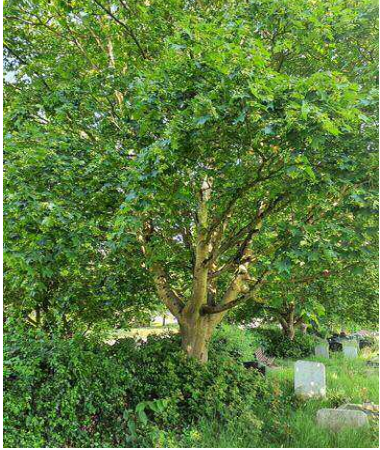
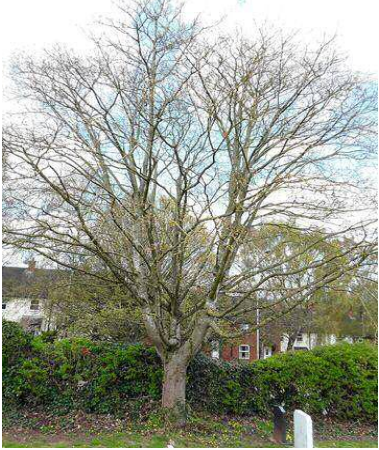
2025/0031	Cappadocian maple (<i>Acer cappadocicum</i>)	4th in line by roadside hedge	Height (m): 10 Crown Spread (m): 10 DBH (cm): 60 Maturity: Semi Mature Life Exp.: EL (40+ Years)	Advisory - Remove Basal Epicormic and adventitious growth from buttresses and trunks of trees, from ground level to no higher than 2.5m.	1 Year

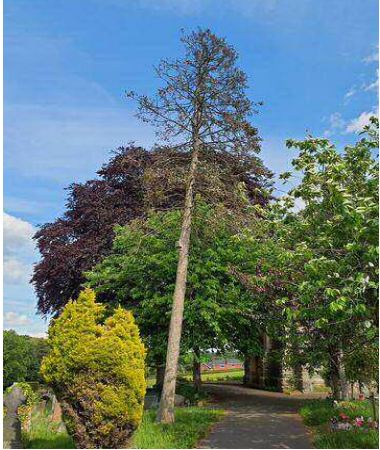
2025/0032	Blue spruce (<i>Picea pungens 'Glauca'</i>)		Edge of grassed area by footway to chapel Cemetery	Mature	1	S <(10 years)	20	5	45	P	V P	Grassed area	Footway	Moderate	1 Year	Tree is nearly dead, with a further thinning of the crown most notably on the northern side. Has declined further since last inspection. Removal now recommended	Medium (150-450mm)	Moderate	Possible (1-5 years)	Low (12-25)

2025/0032	Blue spruce (<i>Picea pungens</i> 'Glauca')	Edge of grassed area by footway to chapel Cemetery	Height (m): 20 Crown Spread (m): 5 DBH (cm): 45 Maturity: Mature Life Exp.: S <(10 years)	Fell to ground level	1 Year

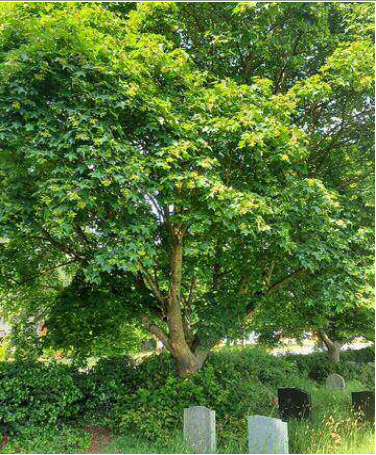
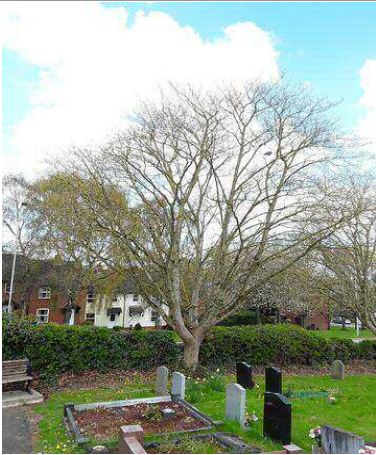
Ref.	Species	Location	Measurements	Task	Priority	Photo		Photo	
2025/0033	Cappadocian maple (<i>Acer cappadocicum</i>)	5th in line by roadside hedge	Height (m): 10 Crown Spread (m): 10 DBH (cm): 60 Maturity: Semi Mature Life Exp.: EL (40+ Years)	Advisory - Remove Basal Epicormic and adventitious growth from buttresses and trunks of trees, from ground level to no higher than 2.5m.	1 Year

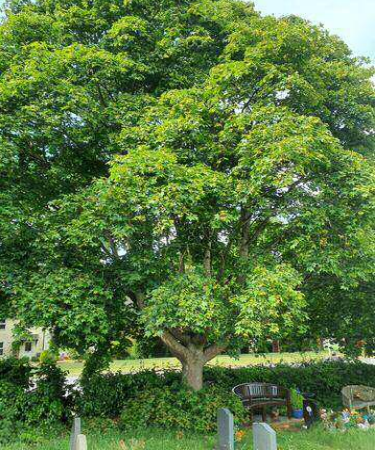
2025/0034	Cappadocian maple (<i>Acer cappadocicum</i>)	6th in line by roadside hedge	Height (m): 10 Crown Spread (m): 10 DBH (cm): 70 Maturity: Semi Mature Life Exp.: EL (40+ Years)	Advisory - Remove Basal Epicormic and adventitious growth from buttresses and trunks of trees, from ground level to no higher than 2.5m.	1 Year

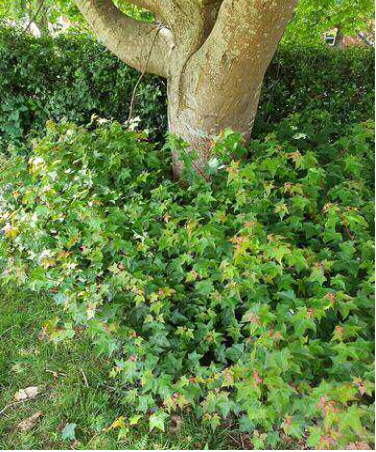
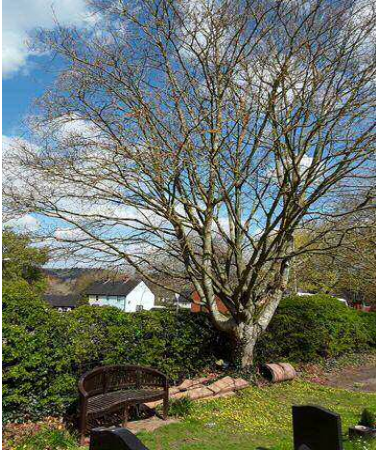
2025/0037	Cappadocian maple (<i>Acer cappadocicum</i>)	9th in line by roadside hedge	Height (m): 10 Crown Spread (m): 10 DBH (cm): 60 Maturity: Semi Mature Life Exp.: EL (40+ Years)	Advisory - Remove Basal Epicormic and adventitious growth from buttresses and trunks of trees, from ground level to no higher than 2.5m.	1 Year

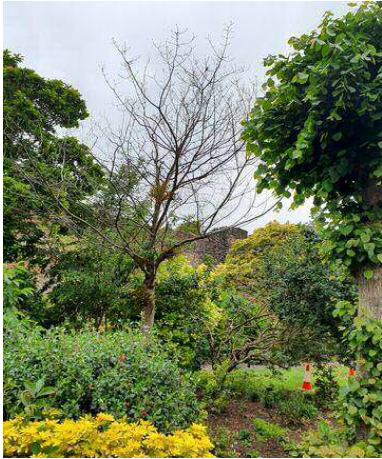
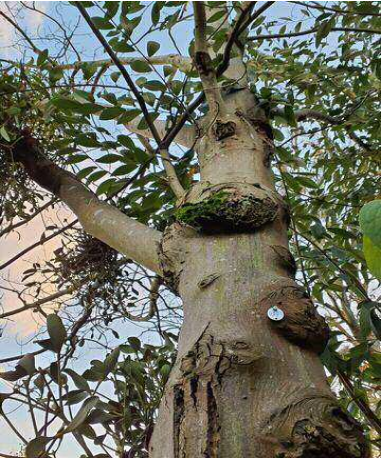
Ref.	Species	Location	Measurements	Task	Priority	Photo		Photo	
2025/0081	Maple (<i>Acer sp.</i>)	Centre of shrub bed Formal Park	Height (m): 5 Crown Spread (m): 10 DBH (cm): 25 Maturity: Semi Mature Life Exp.: L (20-40 Years)	Fell to ground level	6 Months

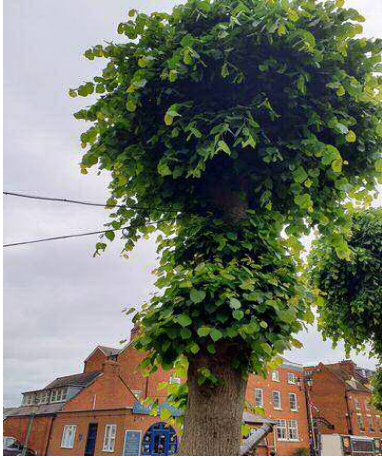
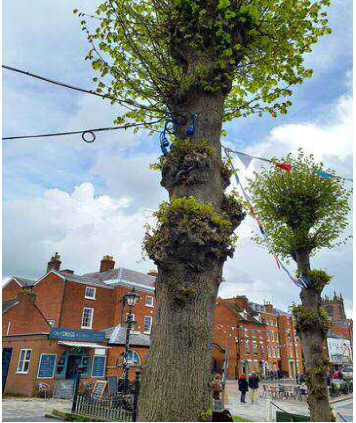
2025/0088	European lime (<i>Tilia x europaea</i>)	Edge of grassed area opposite water fountain Formal Park	Height (m): 10 Crown Spread (m): 5 DBH (cm): 40 Maturity: Mature Life Exp.: M (10-20 Years)	Adjust / replace wire supports at 5m to allow for tree growth. This is becoming an issue	6 Months

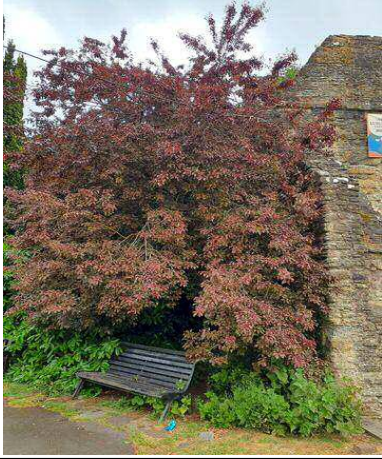
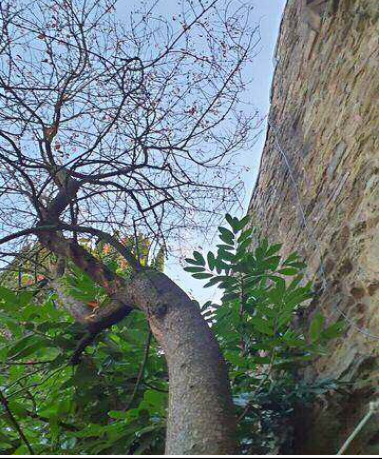
Restrictive growth supports	
2025/0091	Cherry plum 'Pissardii' (<i>Prunus cerasifera</i> 'Pissardi')	In corner of shrub bed to LHS of castle entrance Formal Park	Height (m): 10 Crown Spread (m): 5 DBH (cm): 30 Maturity: Semi Mature Life Exp.: L (20-40 Years)	Crown reduce to clear wall by 2.0m. Crown lift all around to 2.5m. Pruning should be undertaken in midsummer to avoid disease infestation.	6 Months

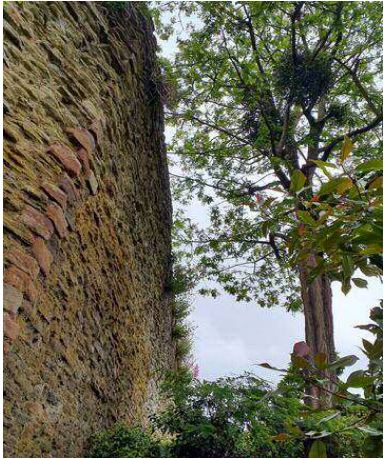
Dead branch		
2025/0078	False acacia (<i>Robinia pseudoacacia</i>)	In shrub bed next to castle Formal Park	Height (m): 20 Crown Spread (m): 10 DBH (cm): 50 Maturity: Mature Life Exp.: L (20-40 Years)	Crown reduce to clear castle wall by 2.0m.	1 Year

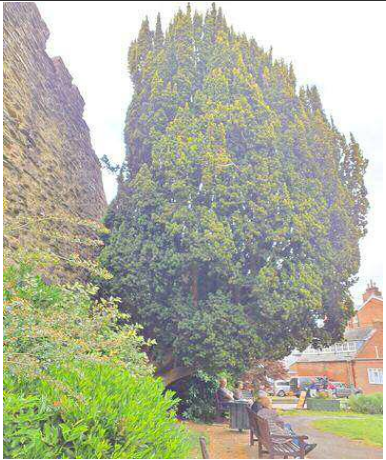
2025/0090	Irish yew (<i>Taxus baccata</i> 'Fastigiata')	In shrub behind bench in front of castle Formal Park	Height (m): 10 Crown Spread (m): 5 DBH (cm): 55 Maturity: Mature Life Exp.: EL (40+ Years)	Crown reduce to clear building by 1.5m. Pruning cut(s) should be the minimum required to achieve aim.	1 Year

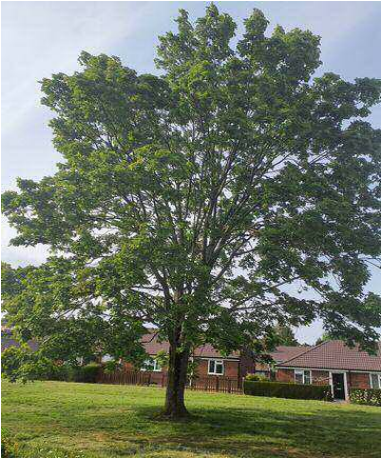
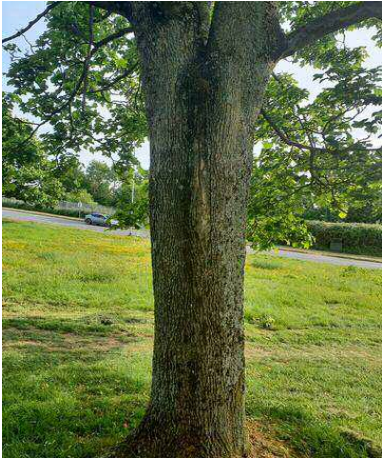
Ref.	Species	Location	Measurements	Task	Priority	Photo	
2025/ 0186	Norway maple (<i>Acer platanoides</i>)	Centre of main green opposite bungalows	Height (m): 20 Crown Spread (m): 10 DBH (cm): 55 Maturity: Mature Life Exp.: M (10-20 Years)	Manual decompact radially using hand auger or garden fork, to a depth of at least 500mm and to the extent to tree crown. Incorporate biochar into created holes. Immediately water these holes and mulch area with woodchip to a depth of 75mm.	6 Months

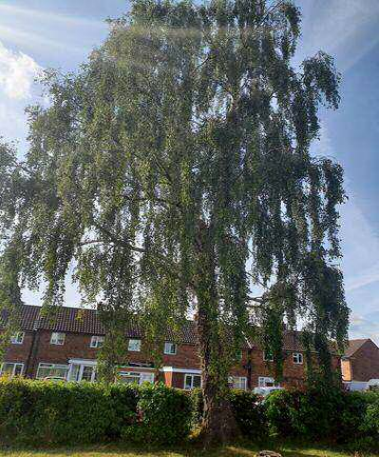
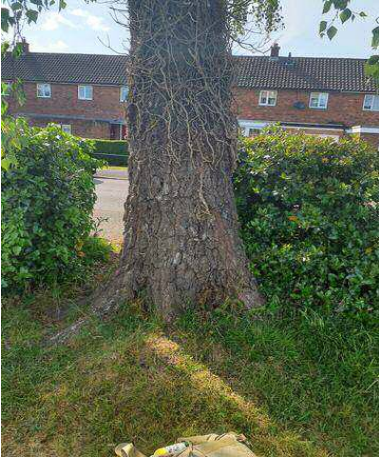
Ref.	Species	Location	Measurements	Task	Priority	Photo		Photo
2025/0158	Silver birch (<i>Betula pendula</i>)	In hedgerow to side of pedestrian entrance Public Open Space	Height (m): 20 Crown Spread (m): 15 DBH (cm): 60 Maturity: Mature Life Exp.: M (10-20 Years)	Fell to ground level	6 Months

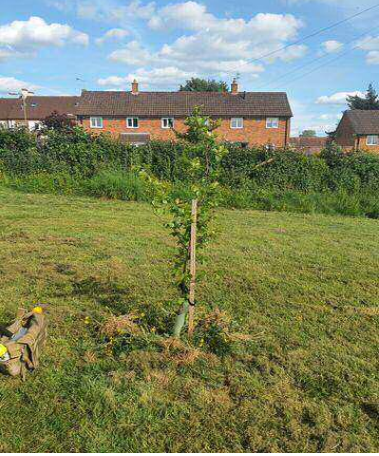
2025/0185	Common beech (<i>Fagus sylvatica</i>)	Corner of open space	Height (m): 5 Crown Spread (m): 5 DBH (cm): 5 Maturity: Newly planted Life Exp.: EL (40+ Years)	Application of mulch spread as evenly as practicable to a depth of 75 mm over an area of 2 metres diameter with the tree at the centre. The mulch shall comprise of wood chips & leaves which have been composted for at least 6 months and shall not be piled against the bark of the tree. Additionally hand fork decompaction and incorporation of biochar would be advisable	1 Year
