BIENNIAL TREE SURVEY REPORT

Report No. S/25/17

**Services Committee
23rd July 2025**

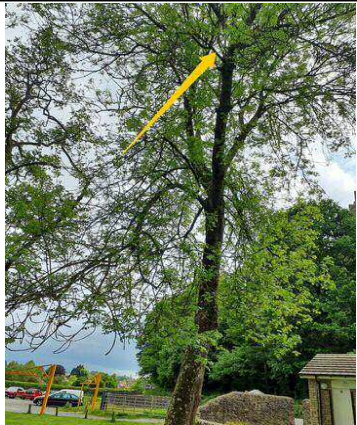
Ref.	Species	Location	Measurements	Task	Priority	Photo	
2025/0104	Common ash (<i>Fraxinus excelsior</i>)	Grassed area by retaining wall and toilet block Formal Park	Height (m): 25 Crown Spread (m): 15 DBH (cm): 75 Maturity: Mature Life Exp.: M (10-20 Years)	Remove dead branch at 9m facing the river	6 Months

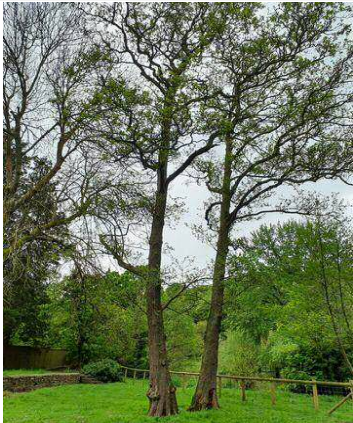
2025/0105	Common alder (<i>Alnus glutinosa</i>)	1 of 2 close growing trees toward toilet block	Height (m): 20 Crown Spread (m): 15 DBH (cm): 75 Maturity: Mature Life Exp.: M (10-20 Years)	Remove all major deadwood (>80mm dia) & stubs from throughout crown. Shorten branches back to live growth where branch ends are dead	6 Months

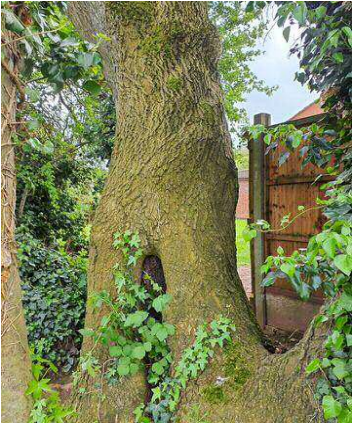
Ref.	Species	Location	Measurements	Task	Priority	Photo		Photo	
2025/0164	Common ash (<i>Fraxinus excelsior</i>)	In old hedge bordering the right of way. Next to garden fence.	Height (m): 25 Crown Spread (m): 15 DBH (cm): 55 Stems: 2 Maturity: Mature Life Exp.: L (20-40 Years)	Sever Ivy & any other climbers from ground level to 1.2m on two stems. To facilitate reinspection.	6 Months

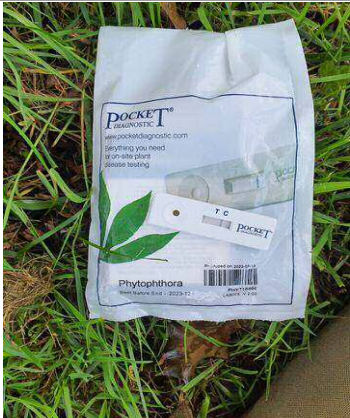
Ref.	Species	Location	Measurements	Task	Priority	Photo		Photo
2025/0011	Common holly (<i>Ilex aquifolium</i>)	In centre of old cemetery area Cemetery	Height (m): 10 Crown Spread (m): 10 DBH (cm): 70 Maturity: Mature Life Exp.: M (10-20 Years)	Advisory - Fell to ground level	1 Year

- **2025/0011 Holly** is in very poor health and appears to be declining possibly dying due to a pathogen infection. An on site test for a pathogen known as Phytophthora was undertaken but the result was negative. Previously recommended work involving the application of woodchip mulch was not undertaken and the tree has declined further making any remedial work unlikely to have any impact. This tree has virtually died and is now identified for removal, although this remains a low risk tree given the location.

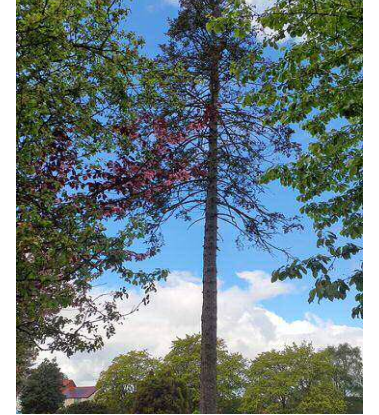
2025/0032	Blue spruce (<i>Picea pungens</i> 'Glauca')	Edge of grassed area by footway to chapel Cemetery	Height (m): 20 Crown Spread (m): 5 DBH (cm): 45 Maturity: Mature Life Exp.: S <(10 years)	Fell to ground level	1 Year

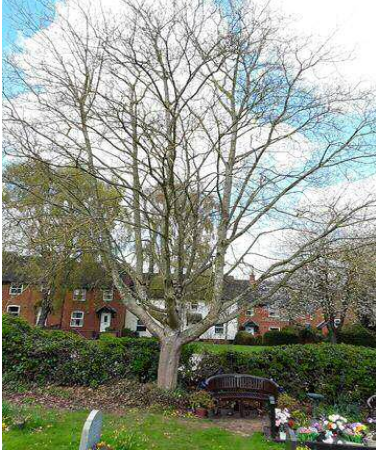
2025/0034	Cappadocian maple (<i>Acer cappadocicum</i>)	6th in line by roadside hedge	Height (m): 10 Crown Spread (m): 10 DBH (cm): 70 Maturity: Semi Mature Life Exp.: EL (40+ Years)	Advisory - Remove Basal Epicormic and adventitious growth from buttresses and trunks of trees, from ground level to no higher than 2.5m.	1 Year

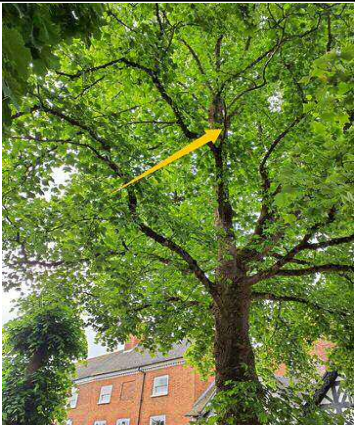
Ref.	Species	Location	Measurements	Task	Priority	Photo		Photo
2025/0068	Tulip tree (<i>Liriodendron tulipifera</i>)	Grassed area by bench Formal Park	Height (m): 20 Crown Spread (m): 15 DBH (cm): 80 Maturity: Mature Life Exp.: EL (40+ Years)	Remove dead branch over the park	1 Year
